**DRAFT**  
**Concept Plan for Future Park Development**

**MIDDLE BRANCH PARK**

City of Baltimore  
Kurt L. Schmoke, Mayor

Department of Planning  
Ernest Freeman, AICP, Director

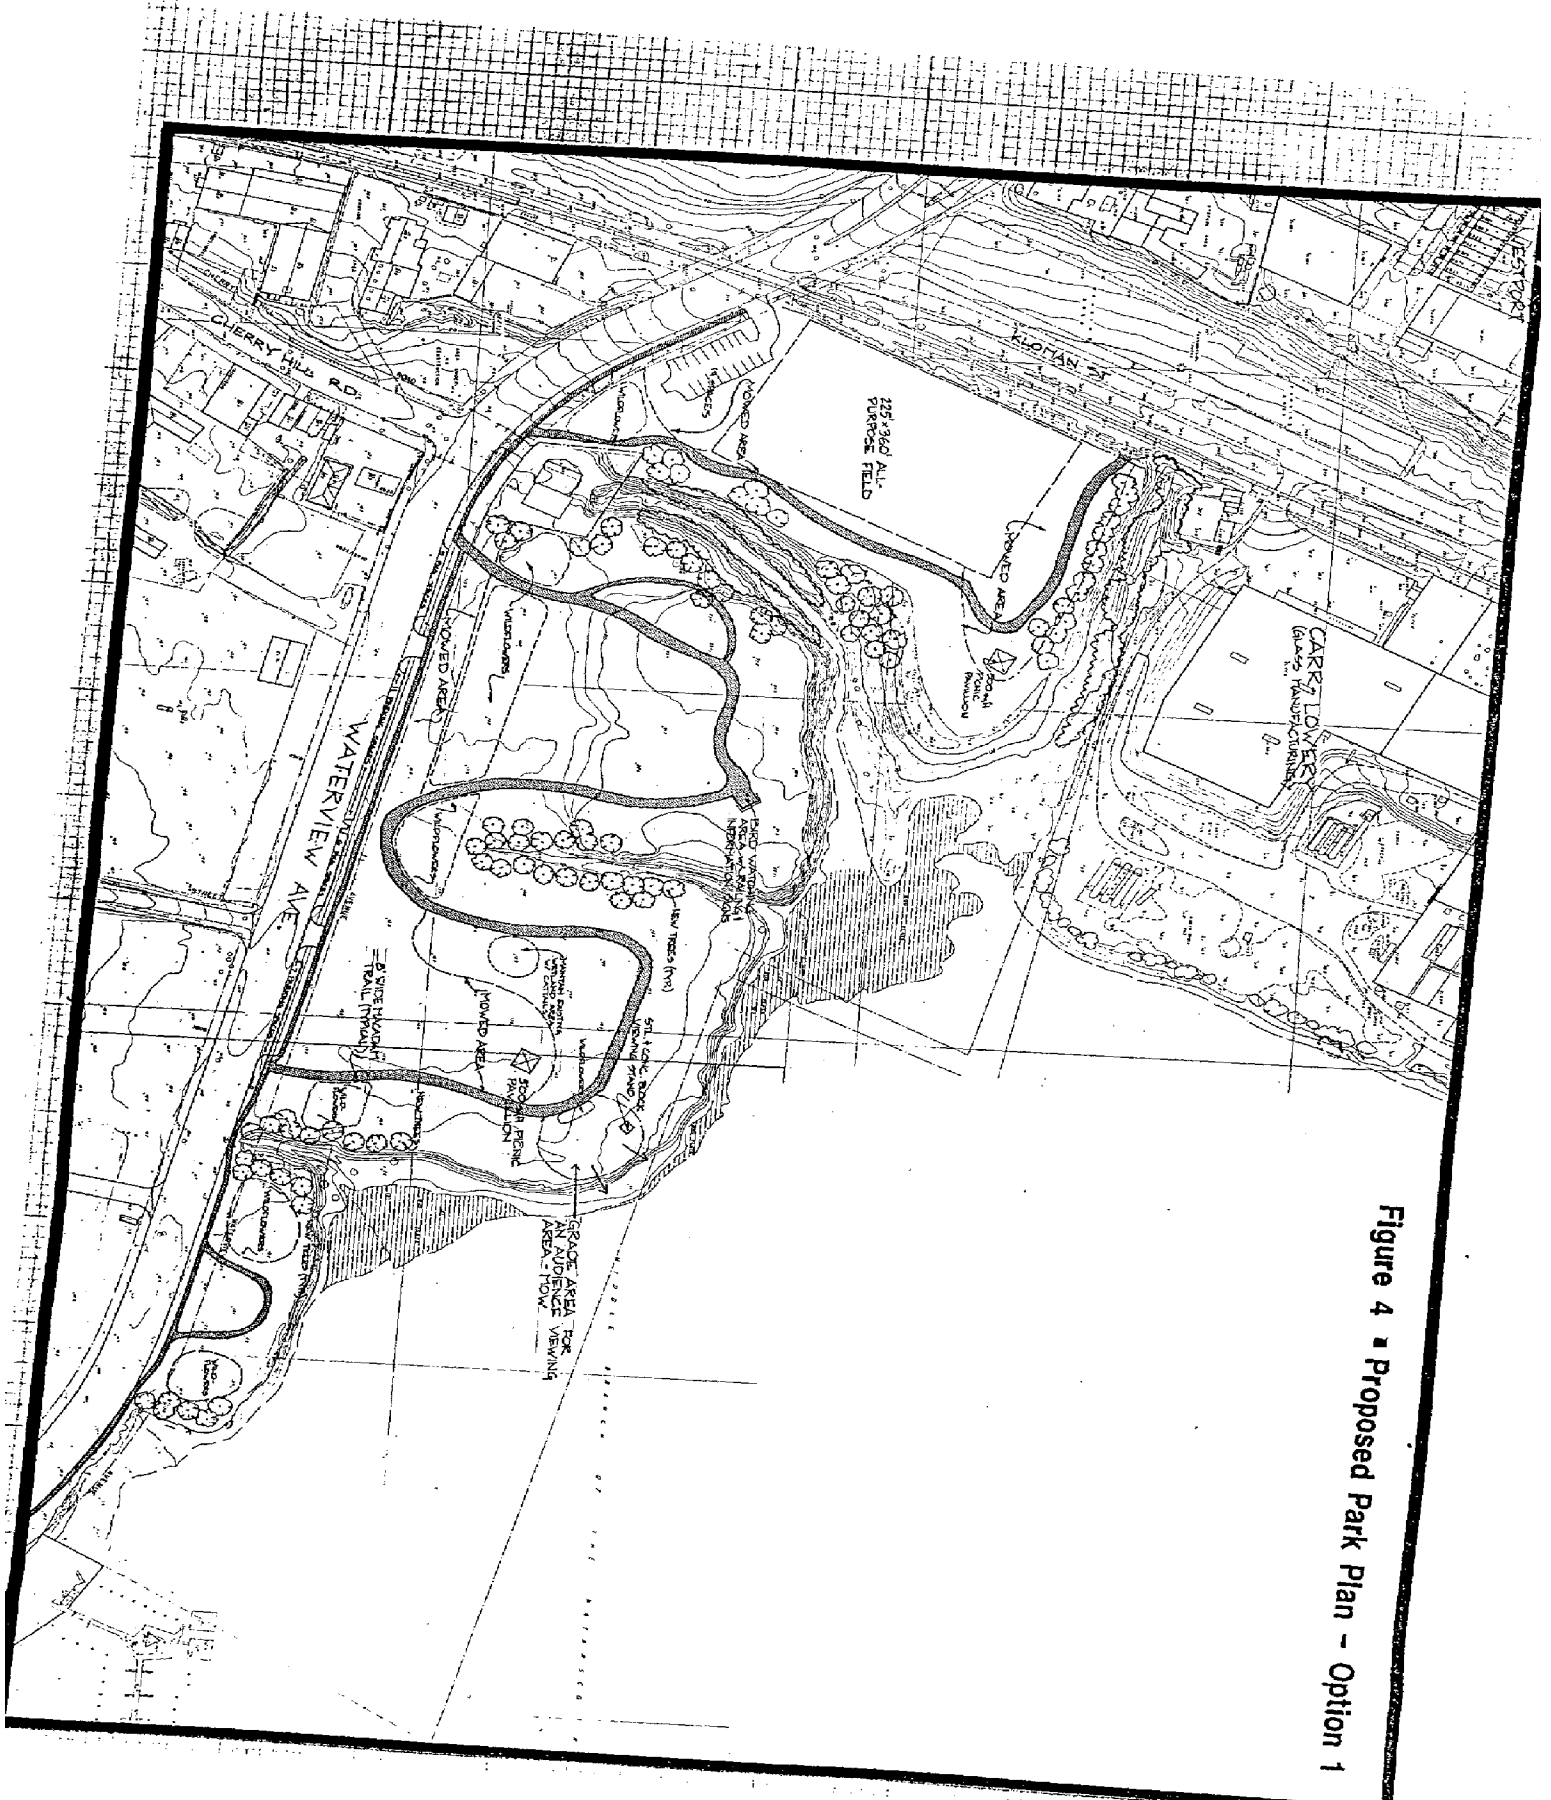
- o Utilize the Chesapeake Clean-up Campaign volunteers to plant additional trees at the site. (Conceptual plans for development of both parcels are shown in Figures 4 and 5.)

- o Enhance the site's natural habitat quality by planting trees along the drainage swale and stream corridor. Plant portions of the site with wildflower meadows. Limit mowing of grass to only small areas of the site which are used for picnicking.

- o Allow for passive recreation on the site by constructing a bike/hiking trail and picnic pavilion.
